In Search of the Wyatt Chapel Cemetery Boundaries

Rice University
Visiting Graduate Students
Bill Baker
Jared Sallee
July 2010

Running the Distance
Summer 2010
Jan Grout and Sarah Wall

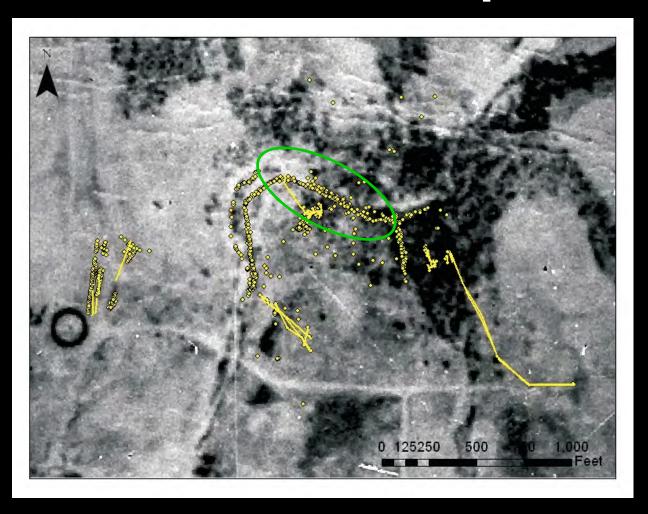
Vegetative Boundary Superimposed Over 1930 Map

- It appears that there is an oval-shaped vegetative boundary marking the cemetery plot.
- It appears that two evergreen trees were planted (one is a stump) near the corner post of the northwest boundary near the creek. We did not locate any other evergreens in the plot area. The two evergreen trees were the oldest trees in the plot and mark the original slave plot.
- In the northwest corner, bottles, broken dishes, and rocks were found. These items have been used in the past to mark slave graves.
- We believe that the oak trees were planted in a pattern at a later time shortly before 1930. The pattern was plotted to establish the boundaries of the cemetery plot.
- We do not feel comfortable at this time establishing the southwest boundary due to the tremendous amount of vegetation found near the creek.

- Continue removing existing brush so that debris, stones, pottery, and impressions can be studied next summer.
- Work with Prairie View A&M to better define the boundaries of the cemetery. We were told that an old plot map existed but it was not available to be integrated into this project.
- Due to the tremendous amount of vegetation on the northwest boundary of the cemetery plot moving toward the creek, we were unable to establish a vegetative boundary.

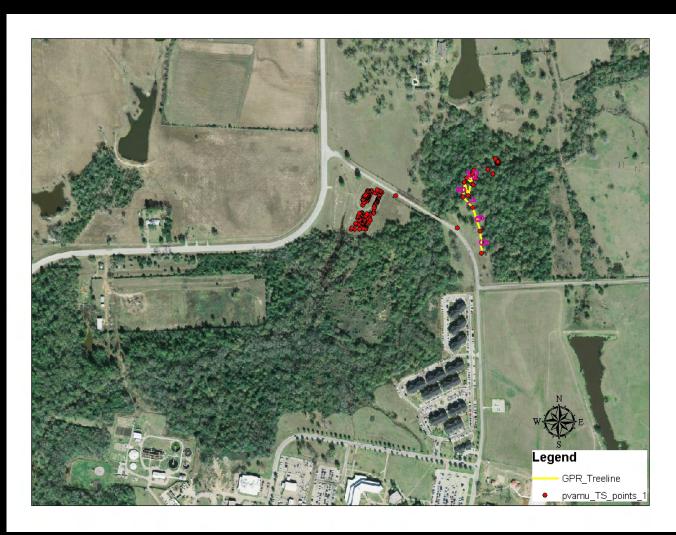
The yellow indicates the area of data collection.

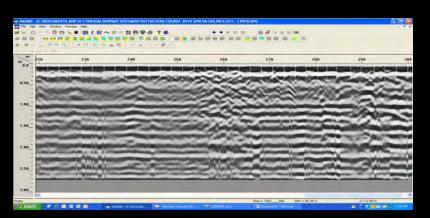
Results

Many shallow anomalies were found which are believed to be tree roots.

- Water Oaks (Quercus Nigra) are the most common tree found along the line.
- The average Water Oak will grow 50'to 80' with a spread of 60'to 70'.
- The root system of the water oak is shallow and widespread. The spread will be roughly the same as the tree canopy.
- The GPR showed shallow anomalies that would be consistent with tree roots.

- There are many shallow, large tree roots that will have to be worked around when putting in the fence post. Care to avoid cutting through many of the roots from the same tree should be taken. If too many of the roots are destroyed the tree will die.
- There are many areas where dumping and litter has taken place. These need to be approached with care, avoiding broken glass and sharp edges.
- The clearing going into the central cemetery area has not shown any noticeable anomalies. Walkways that meet ADA requirements could be made to access existing headstones.

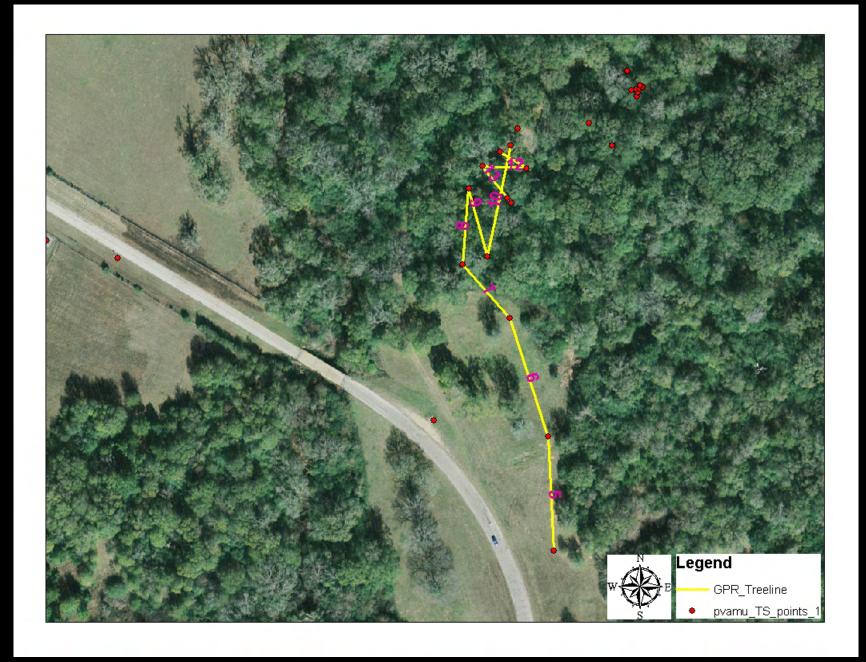
Anomaly Along GPR Line 5

- An anomaly along GPR Line was found.
- A profile was observed that could possibly be the historic creek channel for Pond Creek.
- Historically the creek has moved North to Northwest based on aerial photographs and GPS data from Summer 2009.
